CONTRACTOR REPORT ARPAD-CR-82003

**DETECTION OF CRITICAL DEFECTS IN THE M712
COPPERHEAD CONTROL SECTION HOUSING**

**W. R. RANDLE
B. D. WOODY
MARTIN MARIETTA CORP.
ORLANDO AEROSPACE DIV.
ORLANDO, FL 32855**

OCTOBER 1982

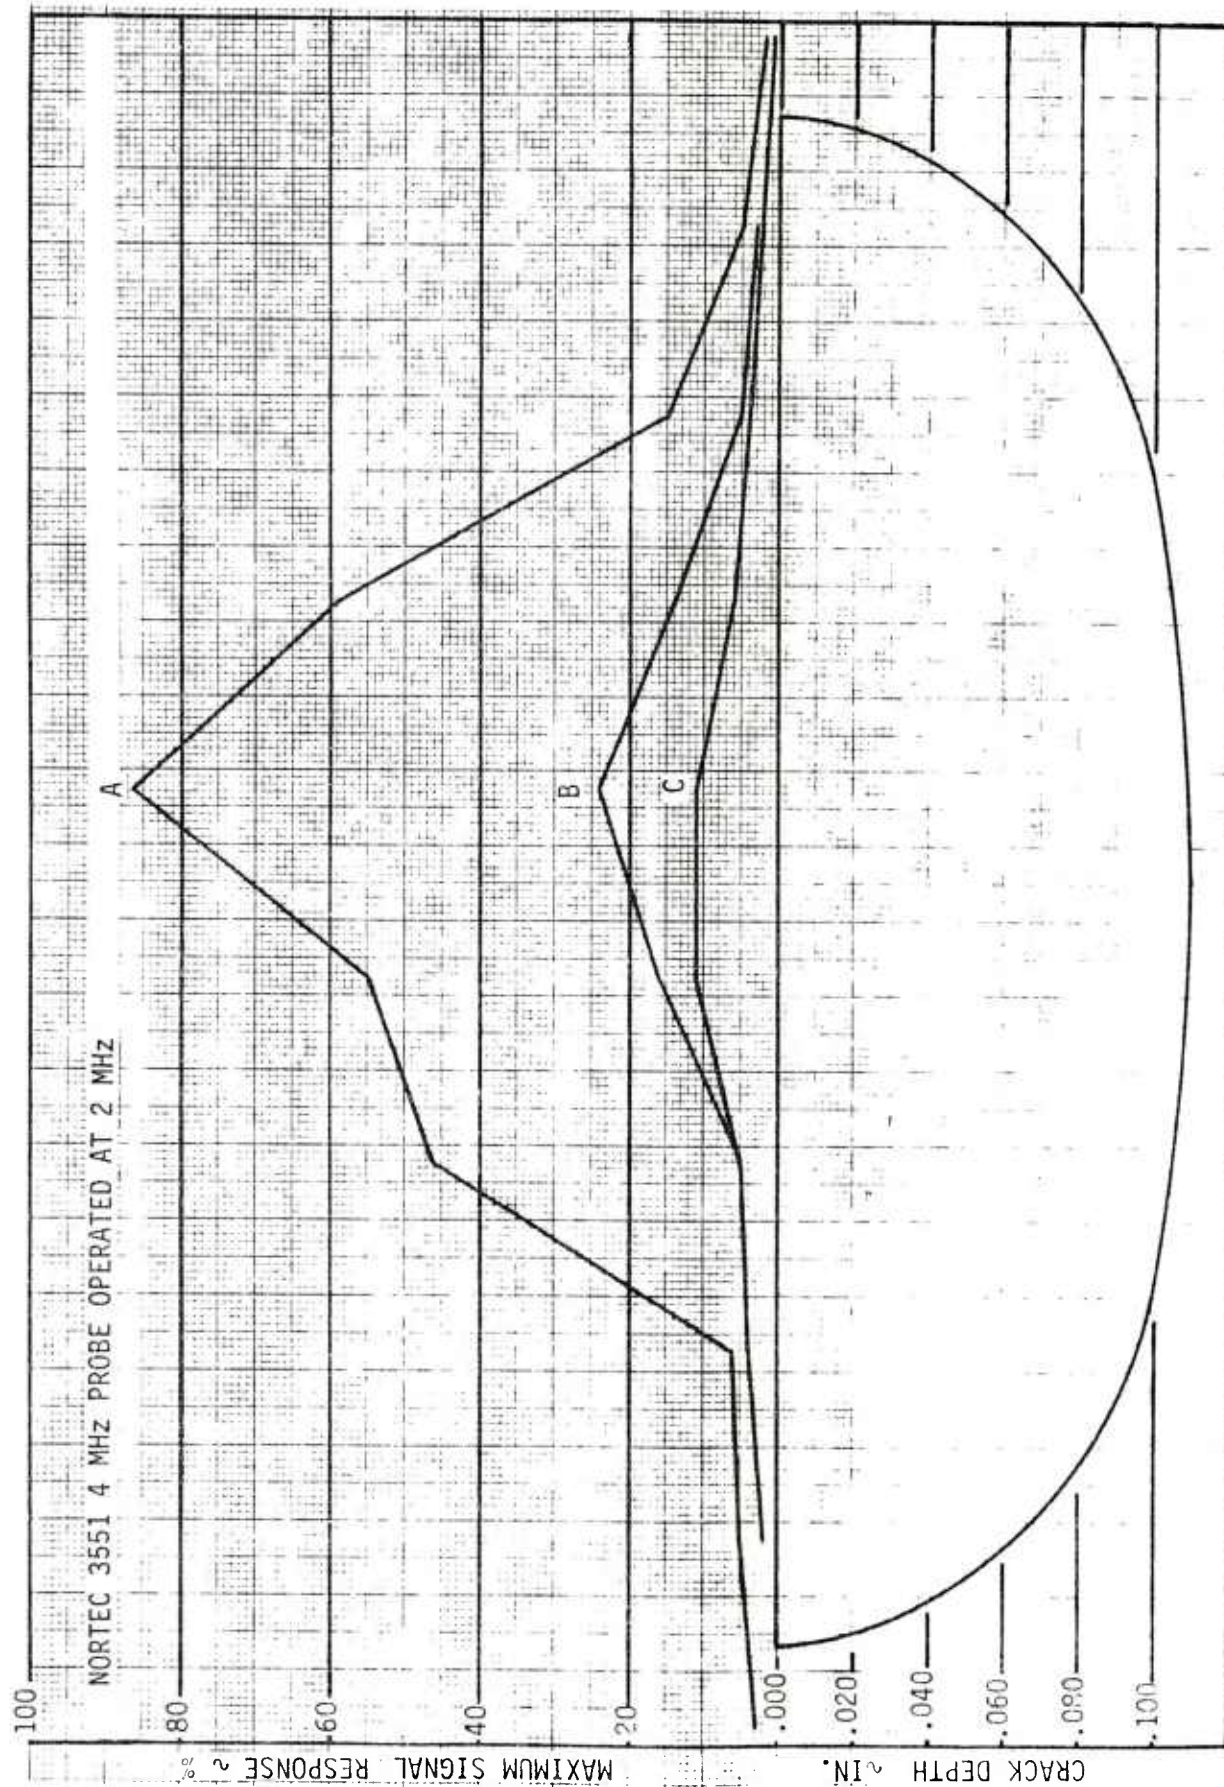
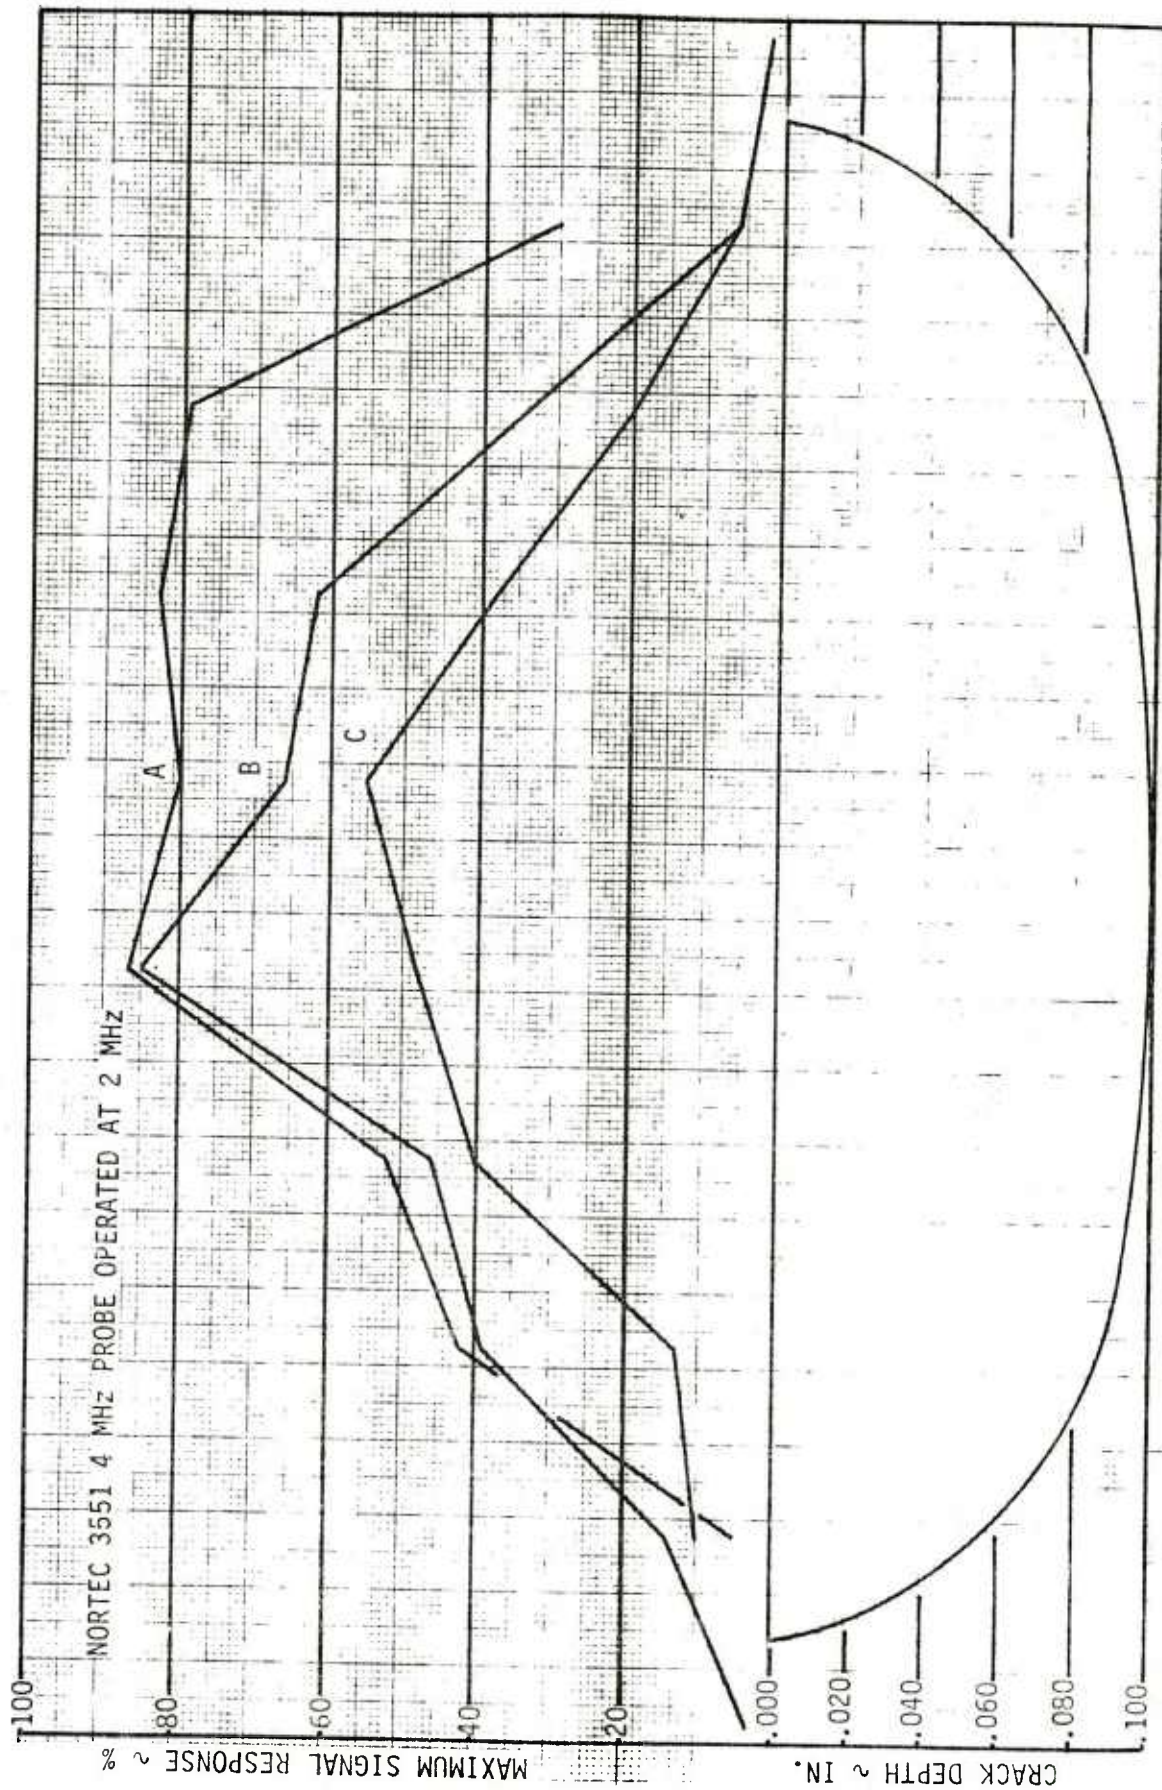
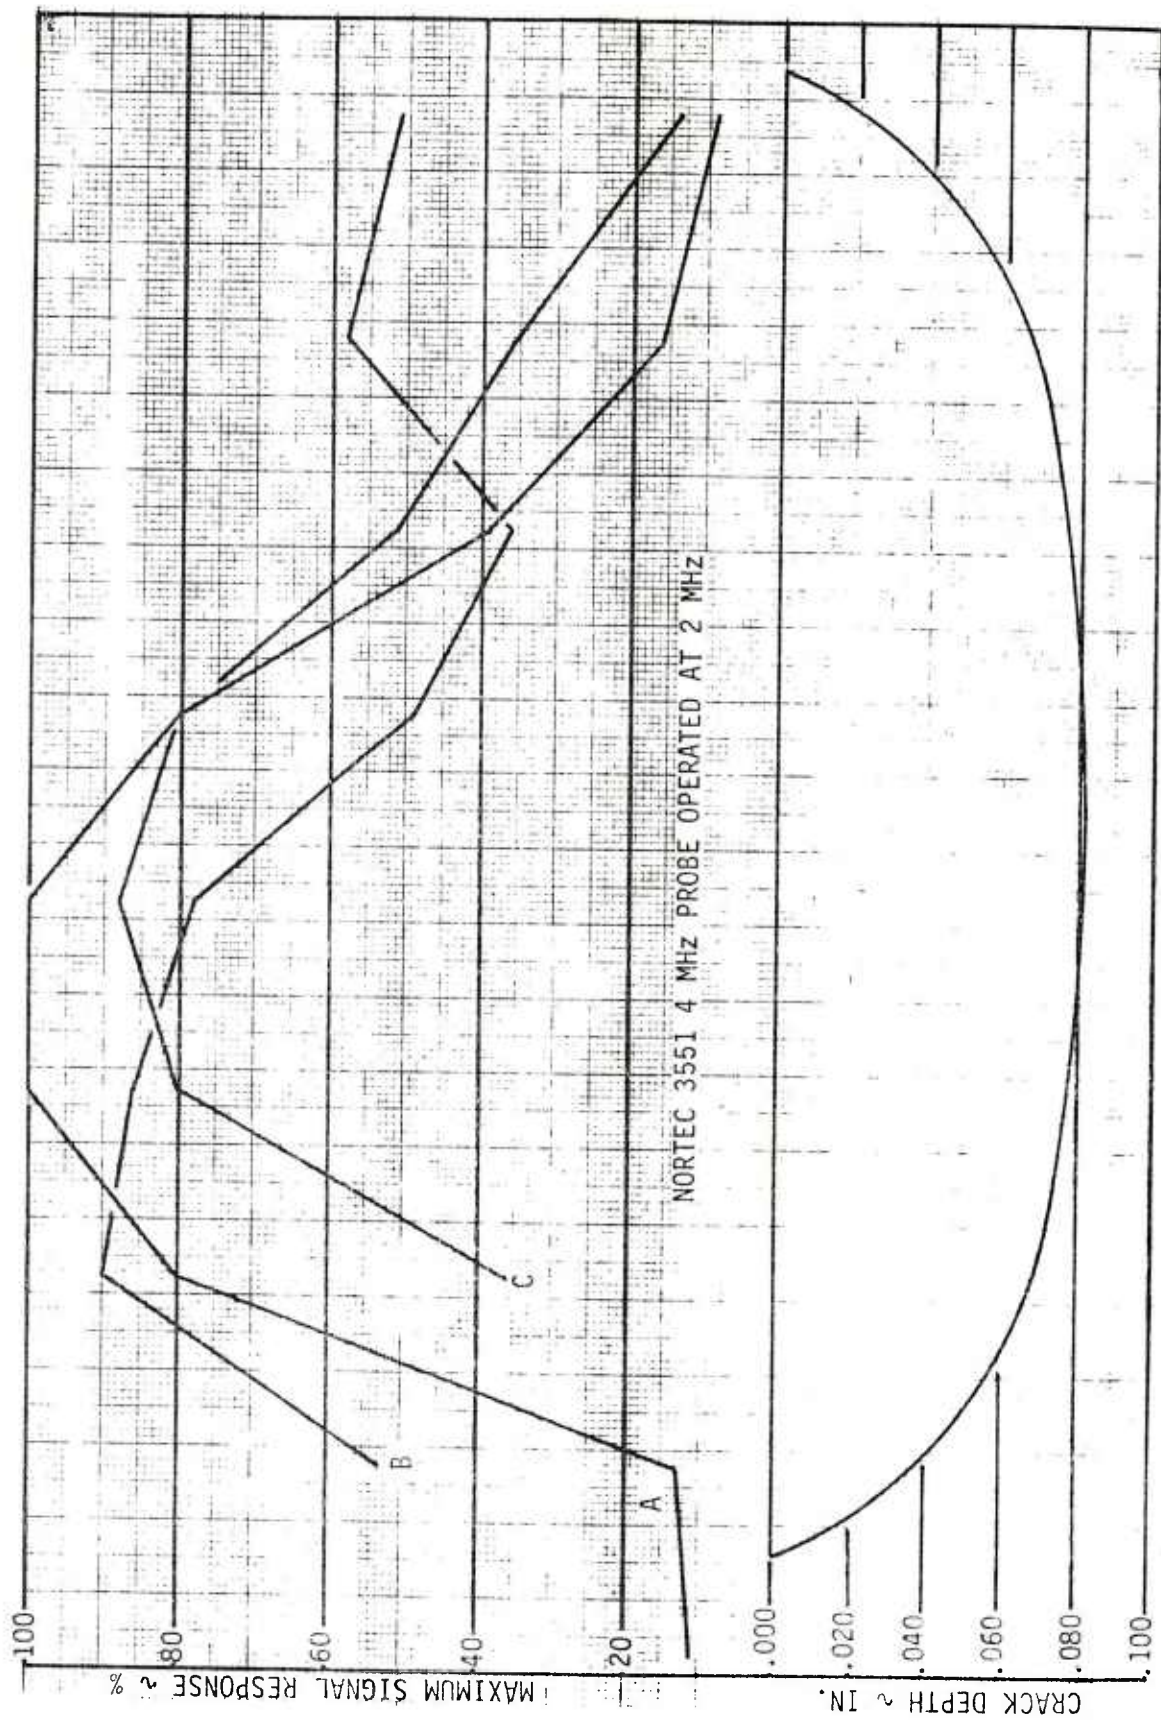
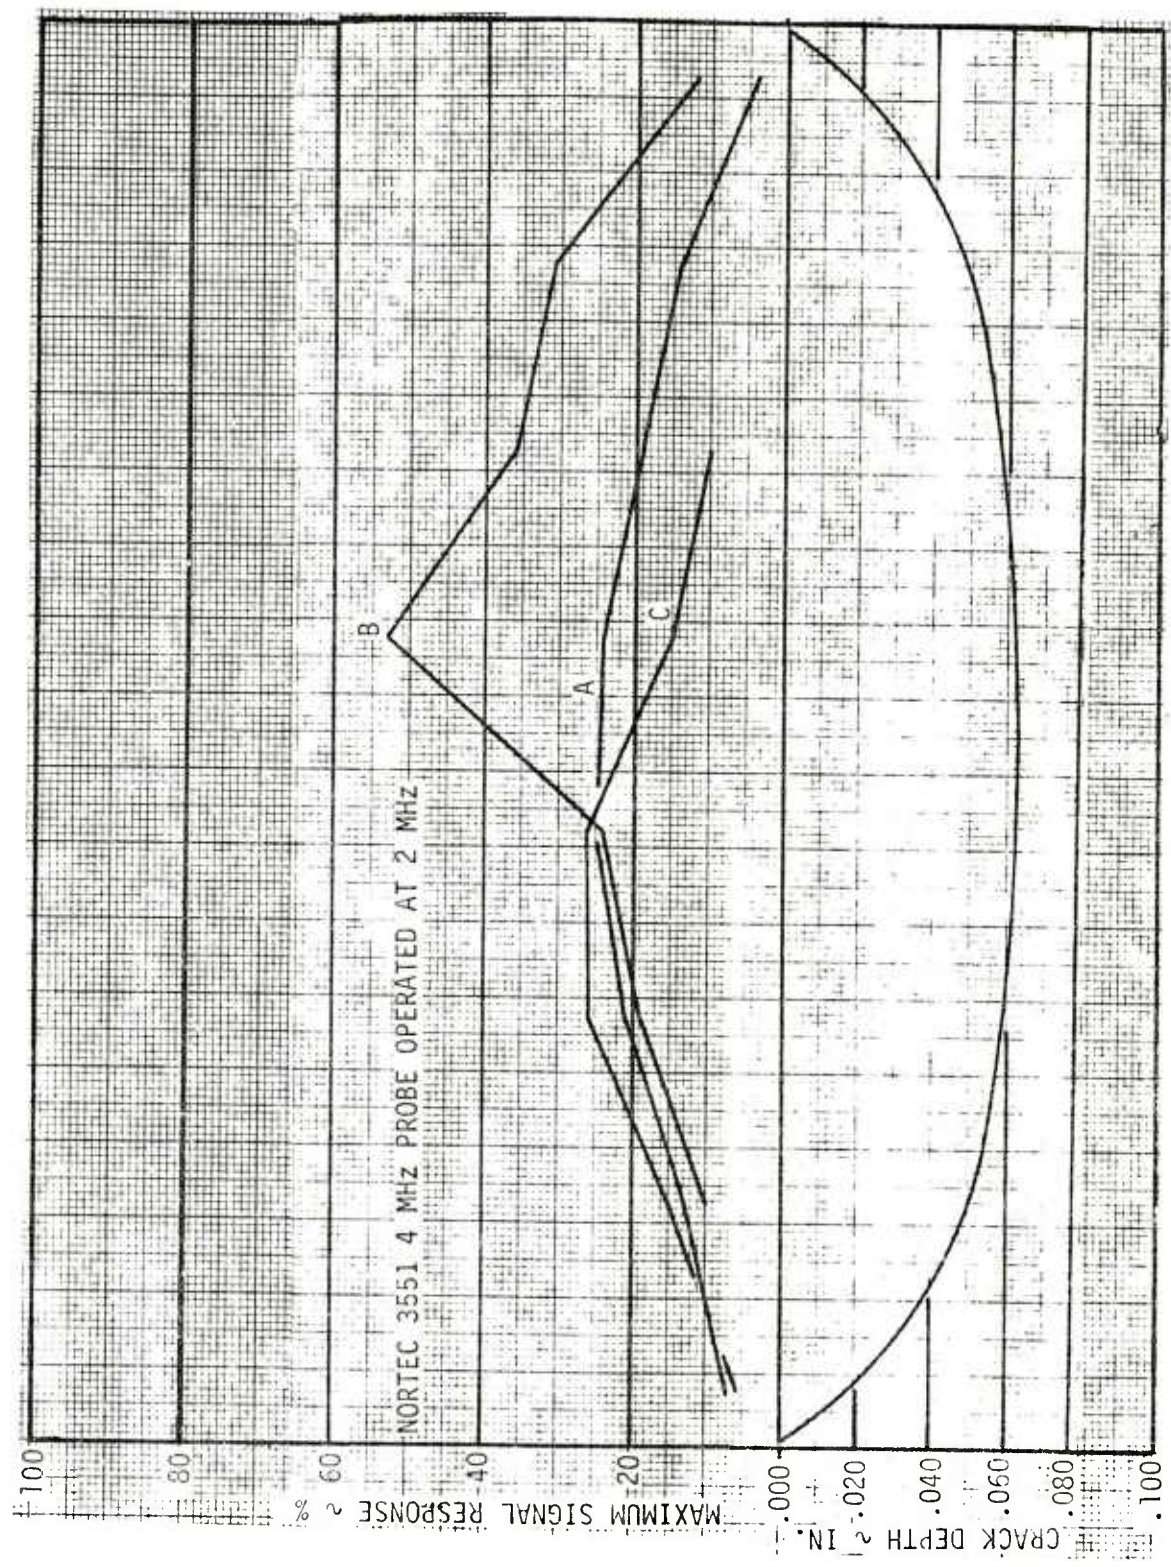
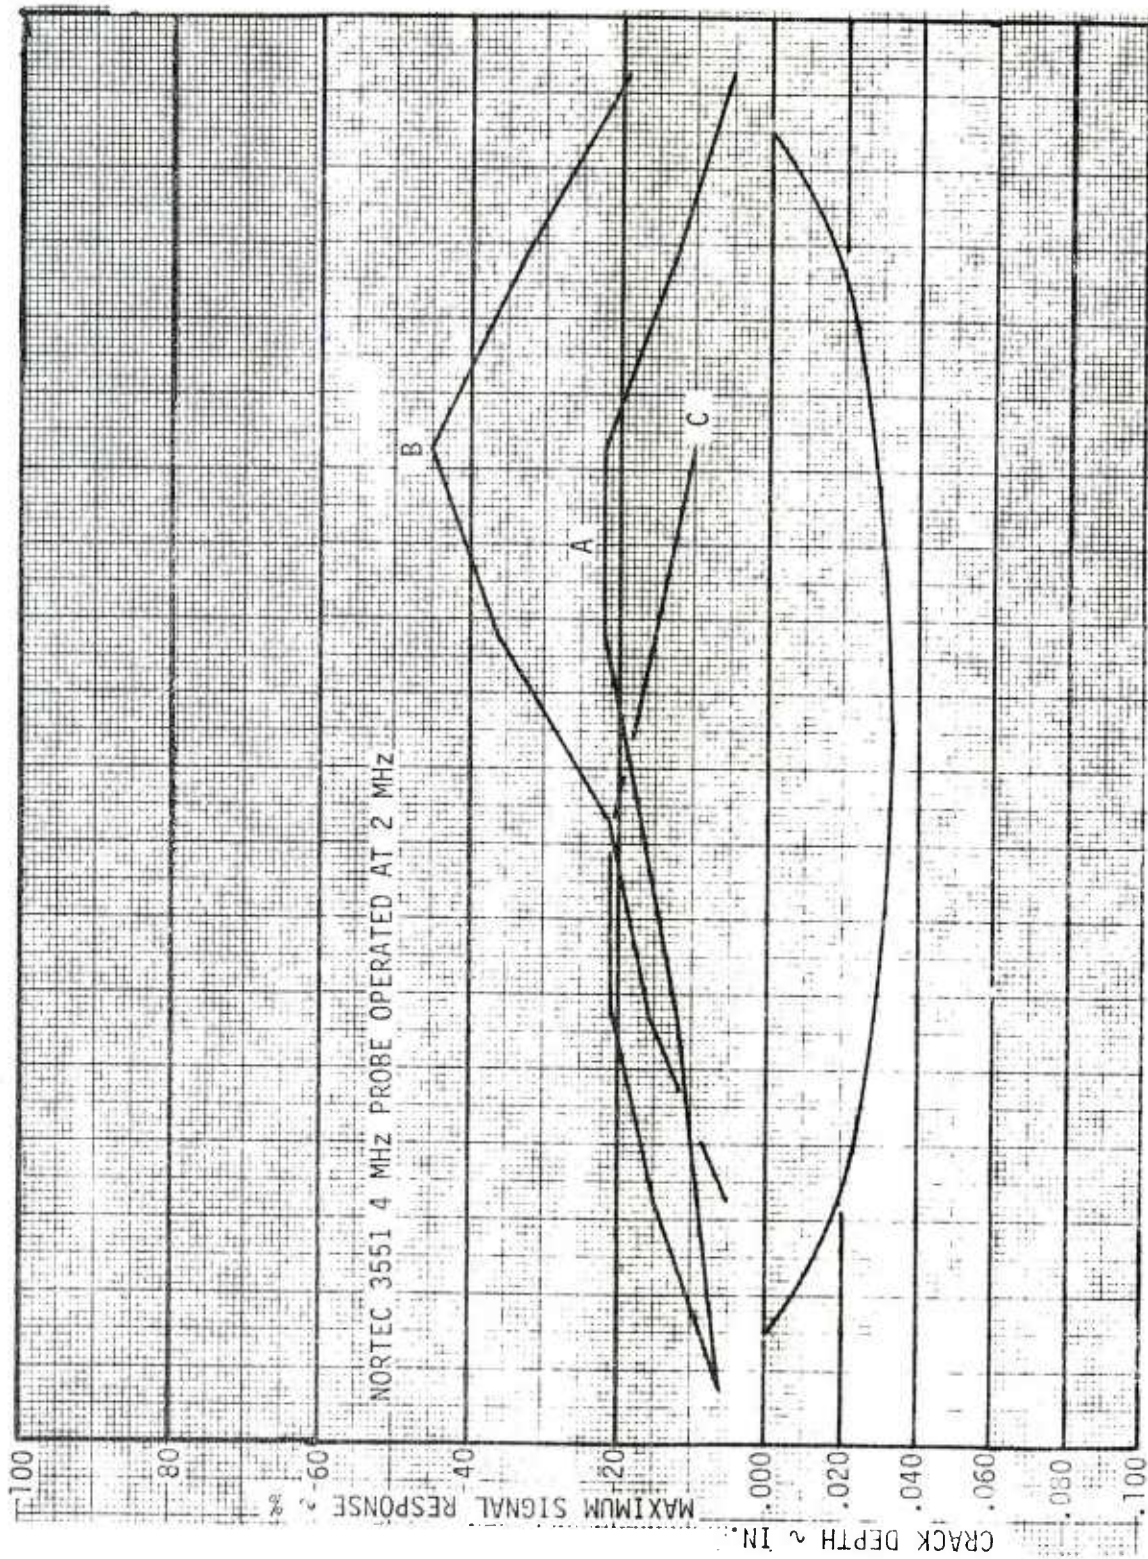
The eddy current signal amplitude versus crack cross section at each depth is plotted in figures 36 through 40. Although the three cracks have identical cross sections, they do not produce identical eddy current profiles, nor do the eddy current signals diminish in amplitude in proportion to the diminishing crack depth.

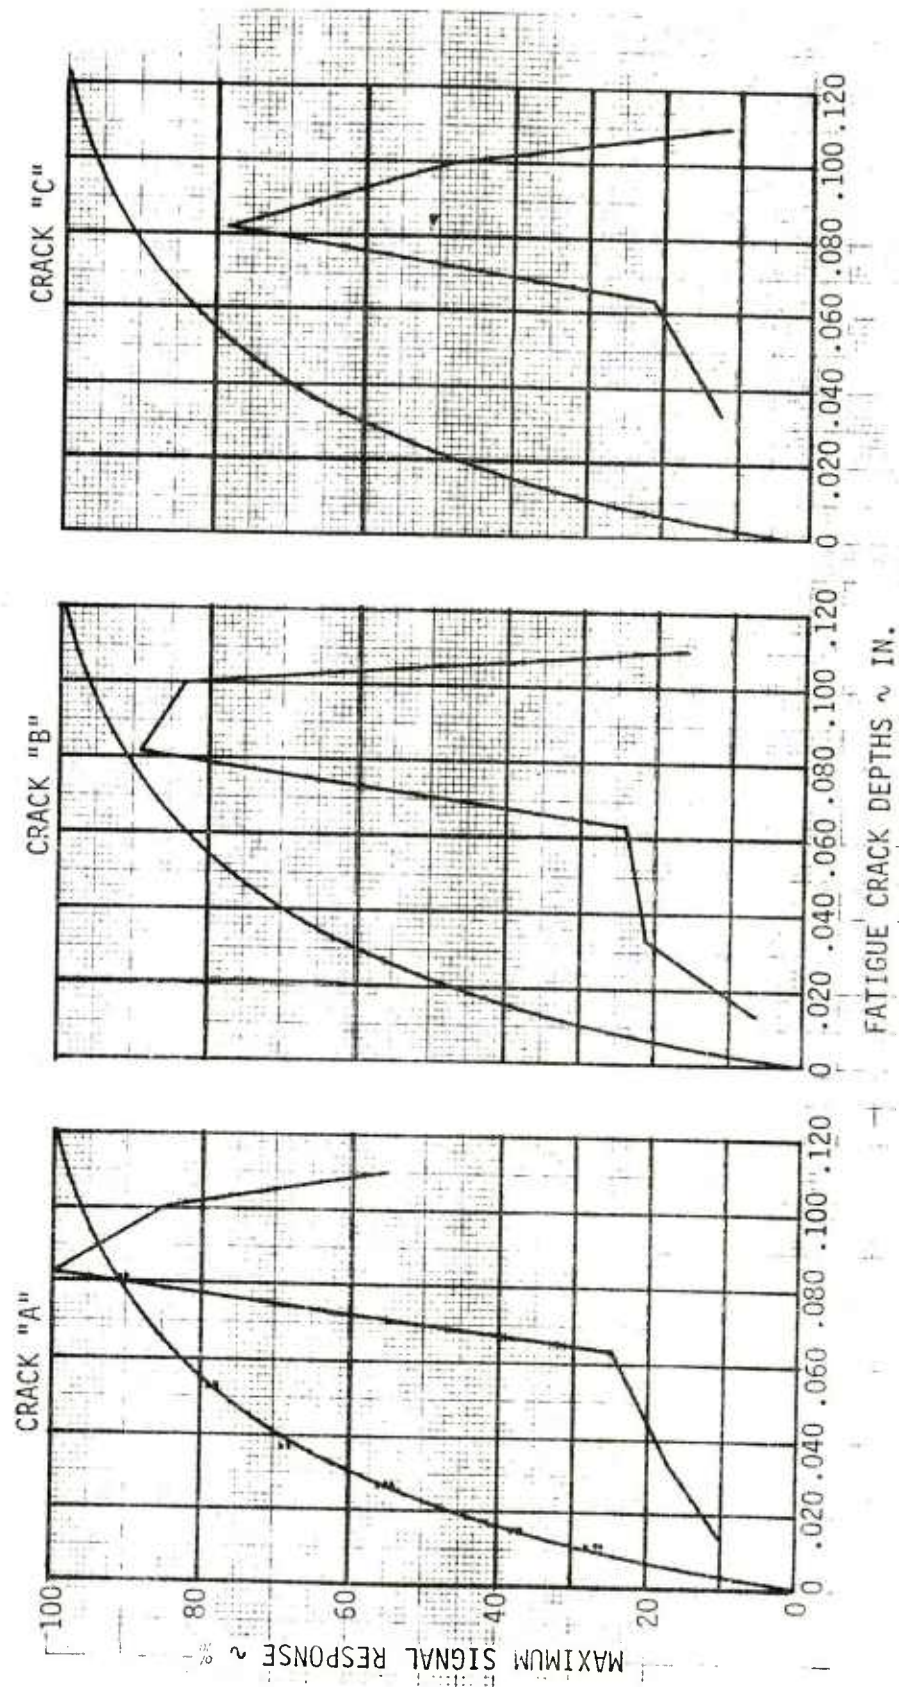
Figure 41. Eddy current response, original centerlines of A, B, and C

A set of plots for the signals produced at the center of each crack as the depth changed versus the response of another Nortec 3551 probe to increasing EDM slot depth (fig. 27) is shown in figure 41.

For the set of three cracks, the crack depth could not have been determined from instrument indications.

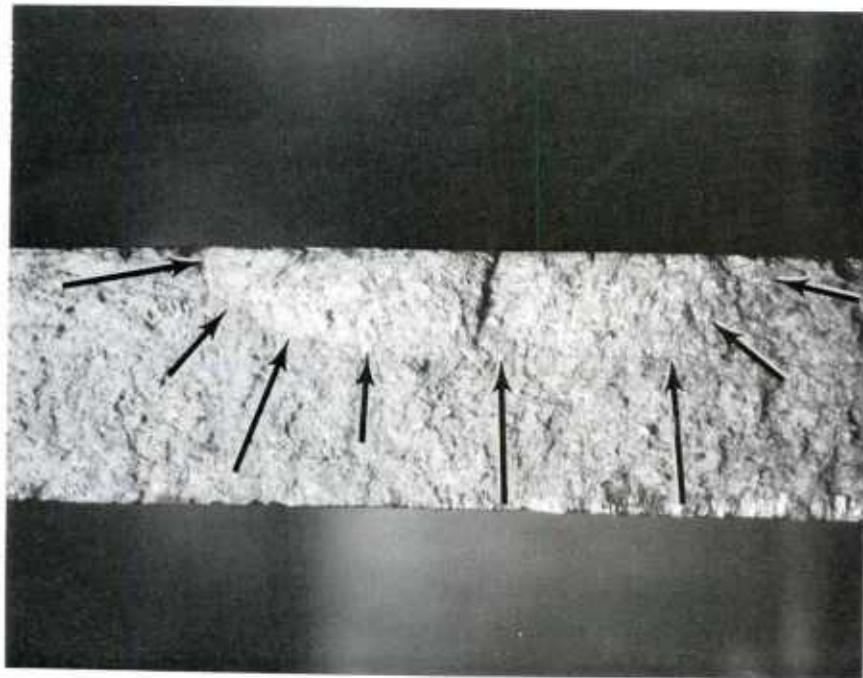
Figure 52. Fracture through fatigue crack

During the fabrication of crack specimen F, another fatigue crack specimen was fractured, and the fracture zone photographed. Further evidence that the dimensional profiles were correct is provided in figure 52.

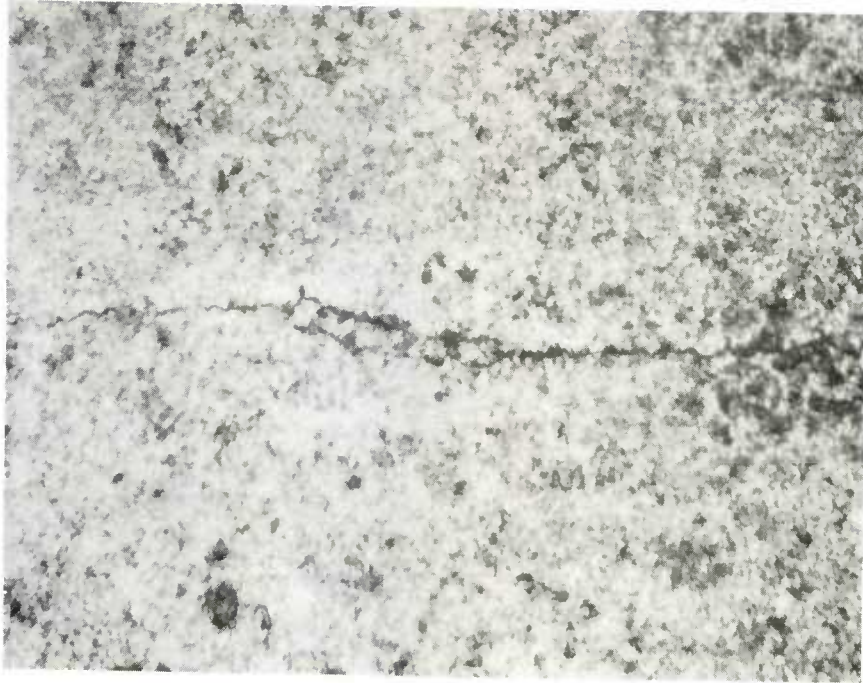
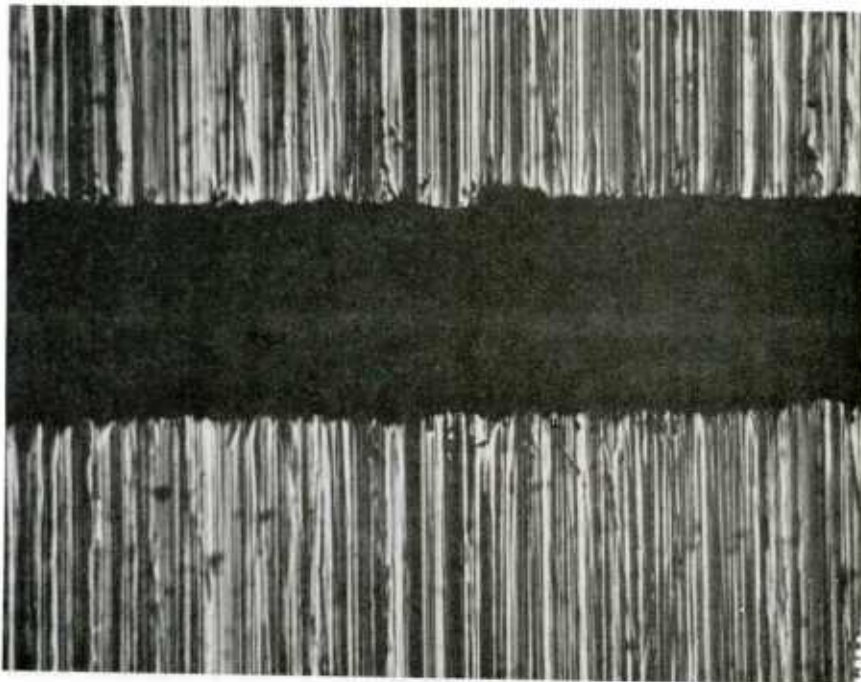
Figure 53. EDM slot versus fatigue crack 300X

As a possible explanation for some of the differences between natural cracks and EDM slots, figure 53 shows the glaring difference between the two under 300X magnification. This photograph also indicates that the violent responses of some of the Reluxtrol 3-152 probe tests are probably invalid for natural cracks.

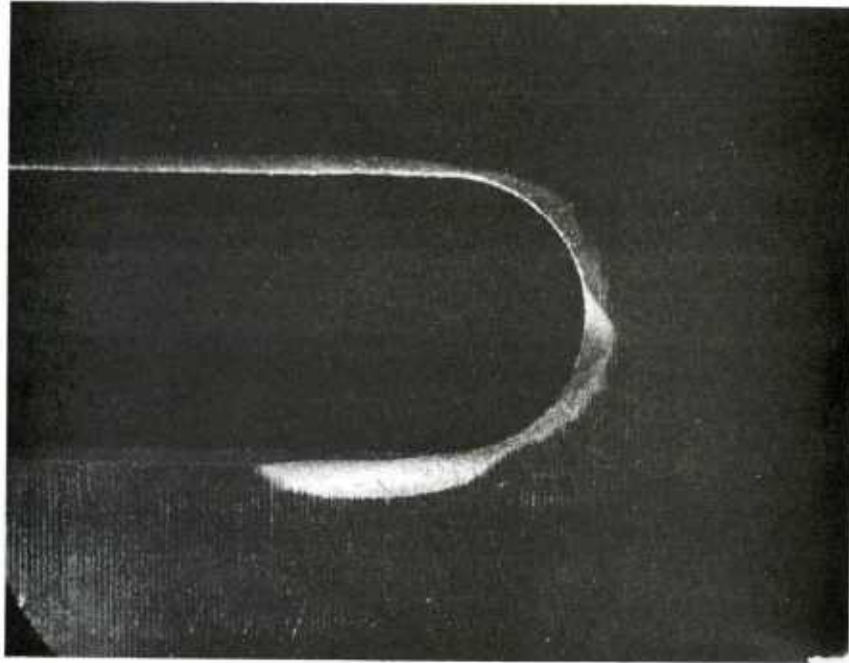
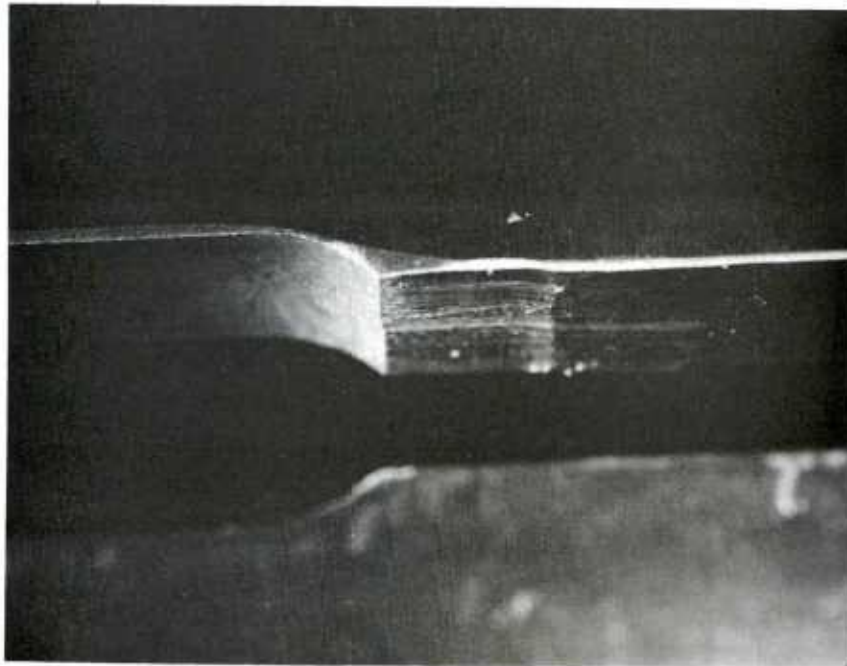
Because of these uncertainties and the geometric variability that results from allowable tolerances and from fabrication processes such as deburring (figs. 54 and 55), the eddy current techniques must be considered unfeasible for accepting or rejecting control housings in accordance with the crack map criteria even though it demonstrated a capability of detecting the critical size flaws.

Figure 54. Slot irregularities, deburring

Figure 55. Slot irregularities, deburring and machining

The current requirements for liquid penetrant inspection, which is capable of detecting the critical flaw sizes per the crack map on over 90% of the surface area, should be continued. The remaining uninspectable areas of the control housing were judged for probability of thermal shock cracking based on the assumption that areas of the most abrupt change in material thickness were most susceptible. This judgement revealed the following three areas remaining of primary concern: 1. the key slot, 2. the support shelf for the wing extension housing, and 3. the fin slots. The fin slots cannot be inspected due to machining irregularities as shown in figures 54 and 55. An authoritative evaluation of these judgements is suggested.
